Martin Slough Enhancement Project 2019 Physical Monitoring Report

Phase 2 – Year 1 Monitoring

Eureka, California

December 2019

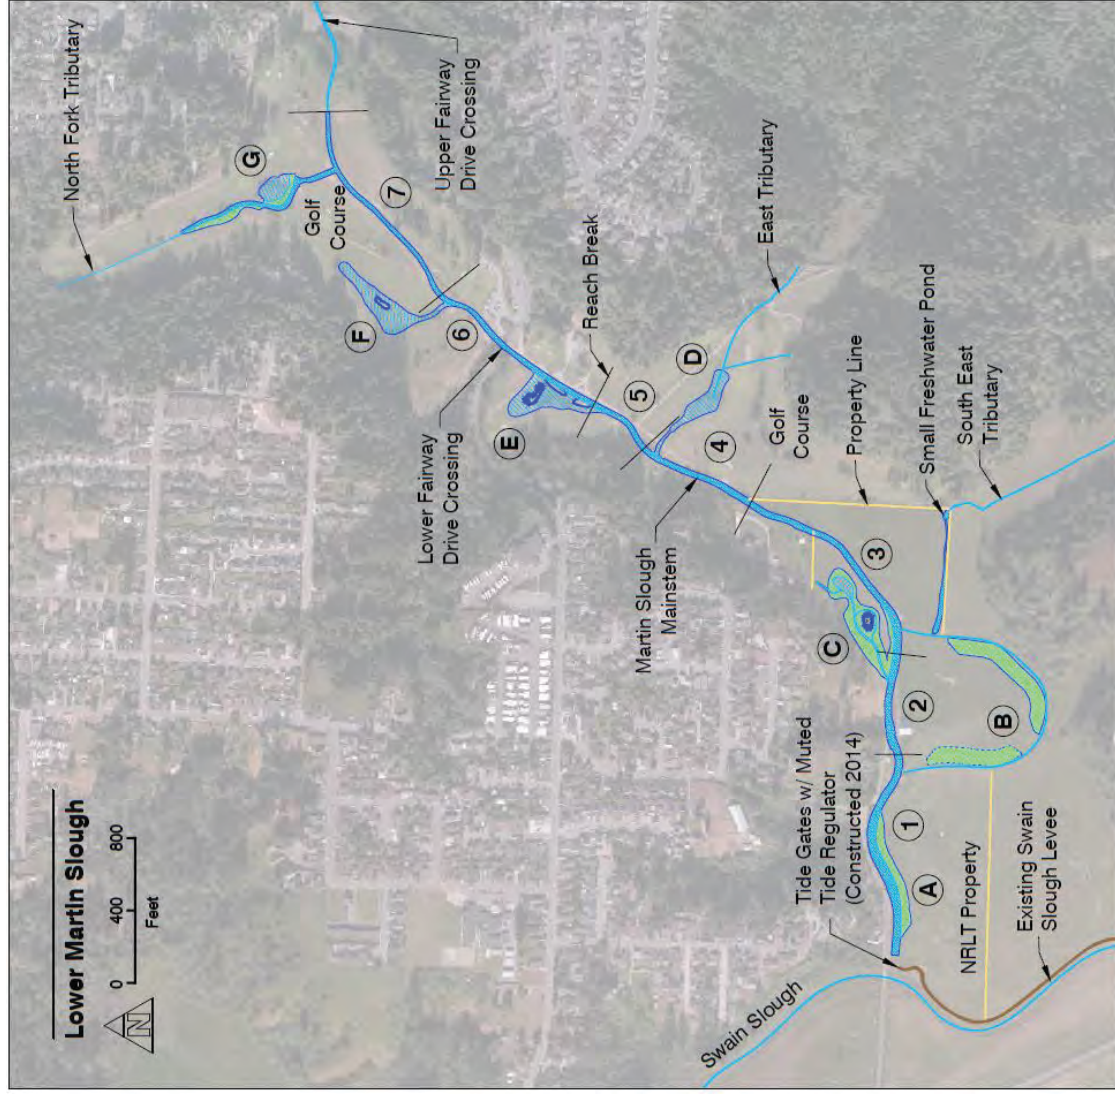
Description of Phasing and Restoration Activities

Phase 1 (2014): Installed new tide gate to restore estuarine ecosystem function, increase conveyance and partially restore muted tidal influence.

Phase 2 (2018): Construction of mainstem Reaches 1, 2, and 3, Marsh Plains A, B1 and B2, Pond C and Southeast Tributary and Pond.

Phase 3 (2019): Construction of mainstem Reach 4 and partial Reach 5, and Pond D.

New channel dimensions - Trapezoidal shape with 1.5:1 (H:V) side slopes and bottom elevation ranges from -1.0 to 2.8 ft. Stable tidal channel geometry based on published relationships of diurnal tidal prism and slough channel dimensions.

Figure 1. Overview of Martin Slough Enhancement Project. Phase 1 (2014) comprised of tide gate replacement, Phase 2 (2018) comprised of Reach 1, 2, 3, Marsh plain A, B, Pond C, and the Southeast tributary, and Phase 3 (2019) included Reach 4 and Pond D.

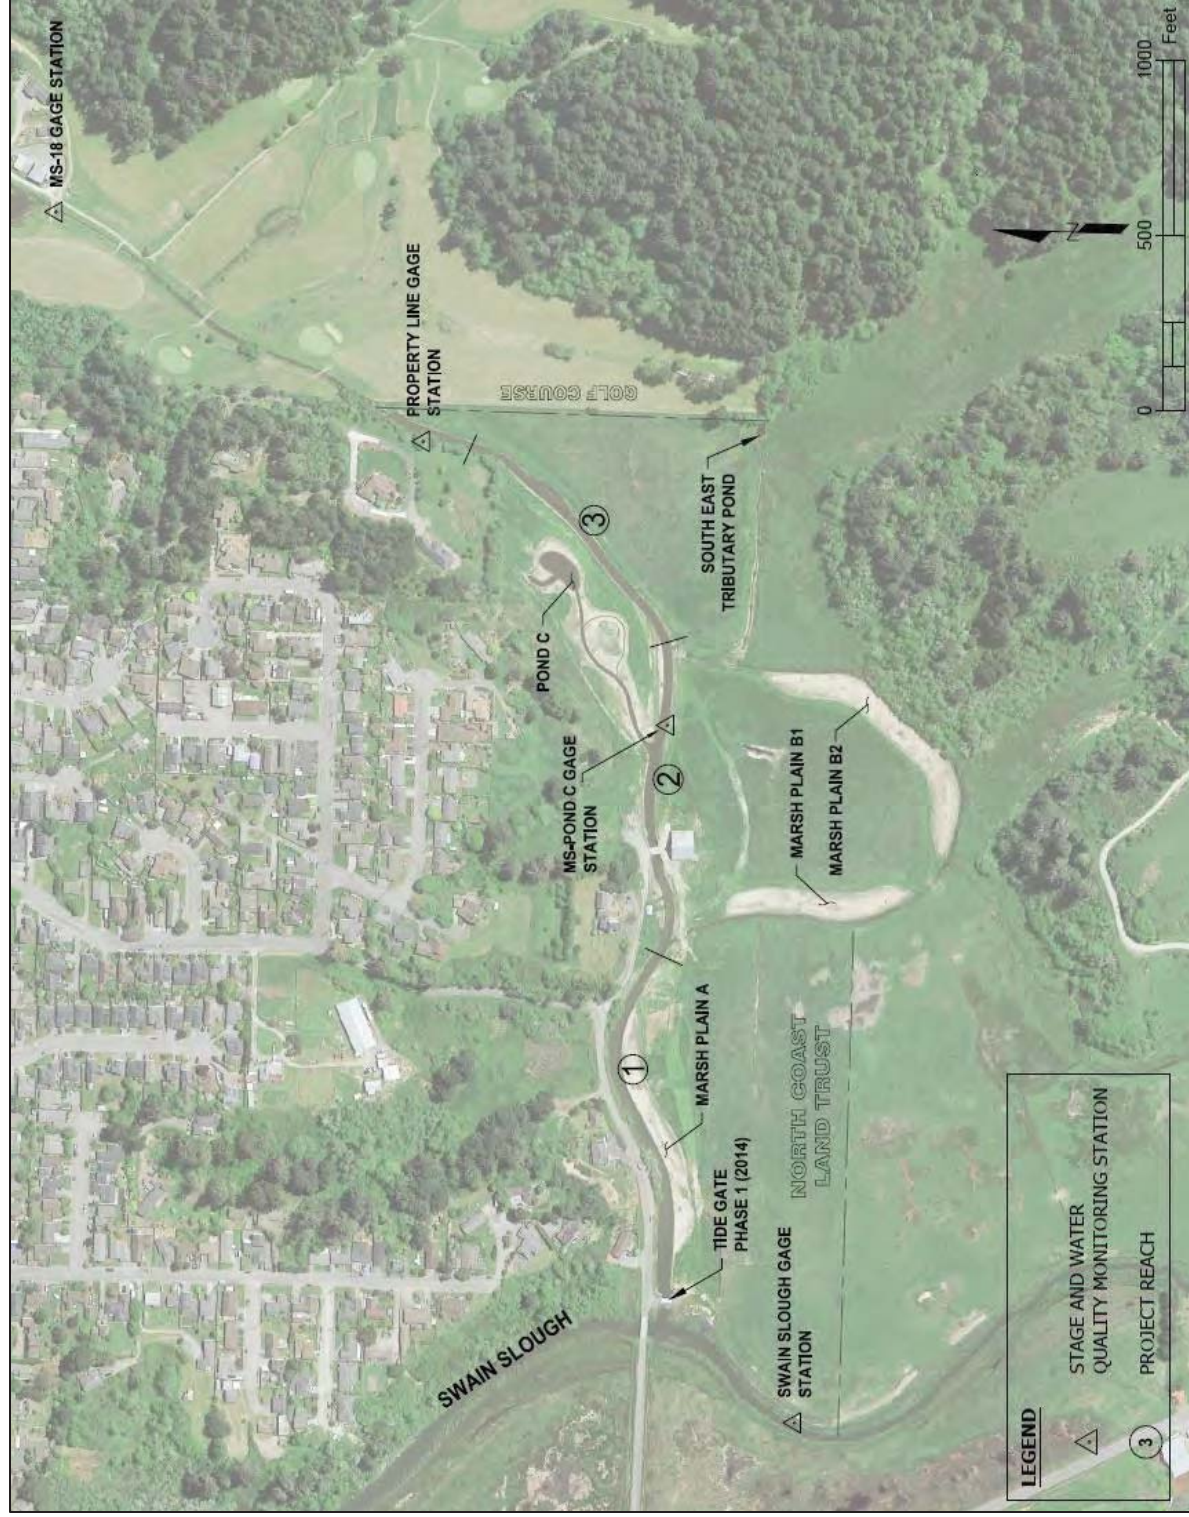
Stage data was recorded after Phase 1 completion starting in March 2017, and expanded after Phase 2 completion. The following monitoring stations/locations were established following Phase 1 and Phase 2 (Figure 2):

Figure 2. Overview of Phase 1 and 2, and location of stage and water quality monitoring stations (image from Google Earth, April 2019).

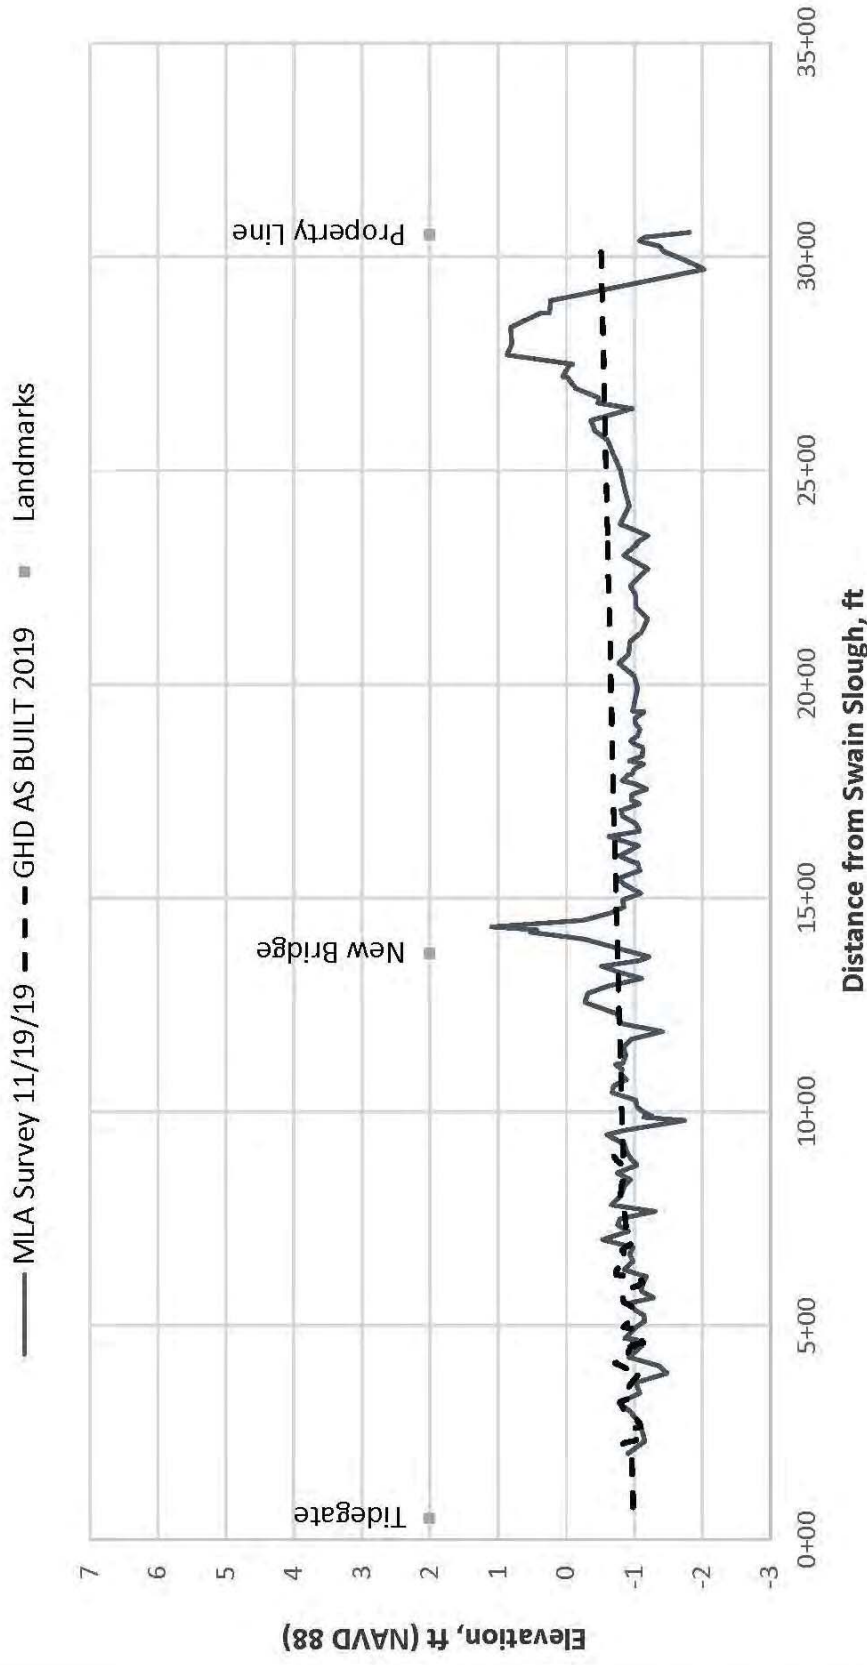
Martin Slough - Mainstem Profile

With the exception of two locations, the existing thalweg is at or slightly lower than design elevations. For the channel reach between Station 15+00 and 25+00 the surveyed thalweg is about 0.3 feet lower than the design grade. It is uncertain if this is from the original grading of the channel or due to scour over the course of Year 1. Future surveys will be used to identify any trends regarding the overall thalweg elevation.

Two notable areas of sedimentation warrant further investigation: Station 14+00 and 27+50. The high spot along the profile at Station 14+00 is approximately 1.8 feet above the design grade. This is located immediately upstream of the new bridge and sheet pile retaining wall at the NRLT barn. A section of the right bank appears to be slumping into the channel when observed at low tide (Figure 4). High groundwater along the base of the adjoining hillslope appears to be driving the instability. During construction this area was recognized as unstable, and some short pieces of sheet pile were driven into the bank at the slump. However, the Year 1 thalweg survey suggests that these sheet piles are not retaining the bank material, and the slump has extended across the entire channel width. Future monitoring will be used to evaluate changes in the channel condition and if any action is warranted.

The second area of note is at Station 27+50, located just downstream of the property line with the golf course. At this location there appears to be approximately 1.5 feet of sedimentation along 50 feet of the channel and then a deep section of channel upstream of the sedimentation. This location coincides with the Phase 2 temporary grade control. This grade control was constructed of rock, and was removed as part of Phase 3 construction in summer of 2019. The over deepened channel section around Station 30+00 was where the rock and sedimentation were removed. The area of sedimentation around Station 27+50 appears to be the tailout from the scour pool downstream of the Phase 2 grade control. This area was beyond the reach of the excavator during the removal of the grade control, and therefore the sediment was left in place. It is uncertain if high flows and tidal action will transport this material downstream. Future monitoring will be used to evaluate changes in the channel condition and if any action is warranted.

Figure 3. Channel profile of Martin Slough along the design alignment. Year 0 is represented by the dashed line as derived from the As-Built plans and the 2019 survey is shown as a solid line and represents the year 1 of Phase 2.

An area of potential concern arising out of the Phase 2, Year-1 monitoring is associated with the two high points identified along the thalweg profile (Figure 3). The high points around Station 14+00 are due to a slumping bank associated with high groundwater and saturated soils close to the base of the adjoining hillslope. Continued slumping at this location could cause a substantial constriction of the channel. A constriction could cause upstream flooding and channel sedimentation, and would limit upstream tidal influences. It is unclear if the channel has the capacity to scour and transport this material downstream to Swain Slough. The project manager and project engineer should inspect this site after extended wet periods and following high flows to detect if any additional slumping occurs, and the site should be resurveyed as part of next year's monitoring activities.

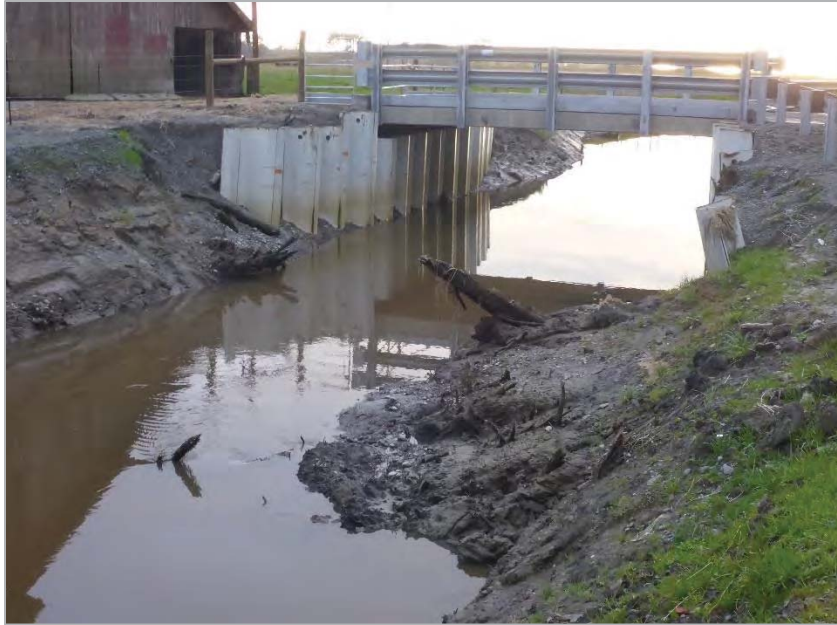
Figure 4. Slumping bank along the right side of the channel immediately upstream of the new bridge and sheet pile retaining wall at Station 14+00 on the profile.

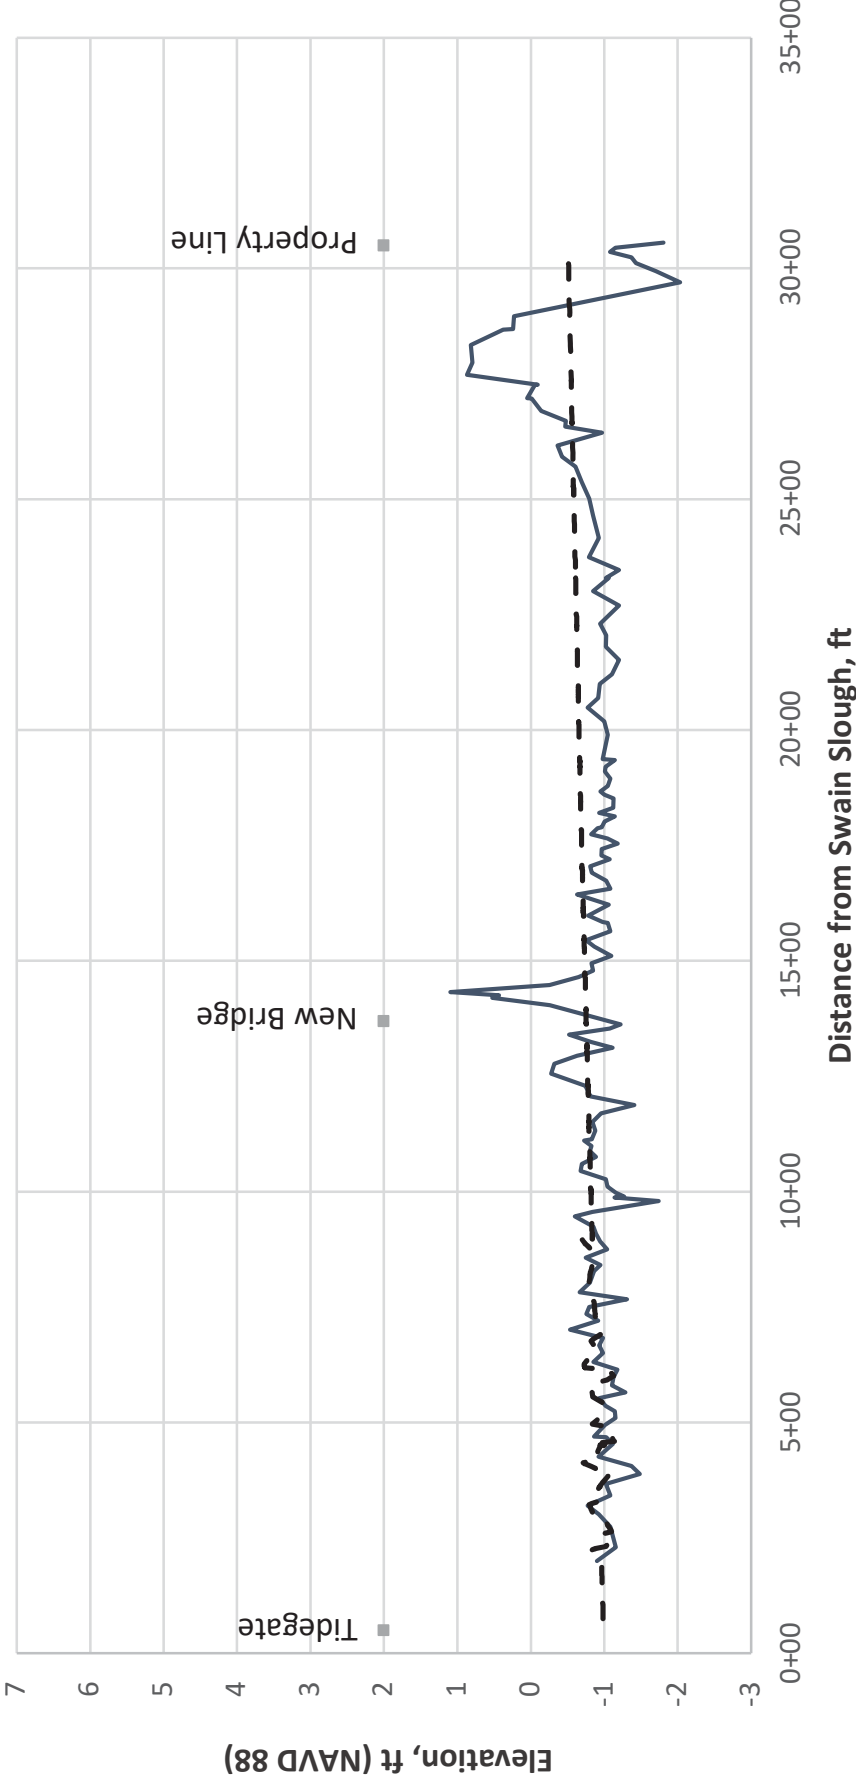
Martin Slough - Mainstem Profile

— MLA Survey 11/19/19 - - - GHD AS BUILT 2019 ■ Landmarks

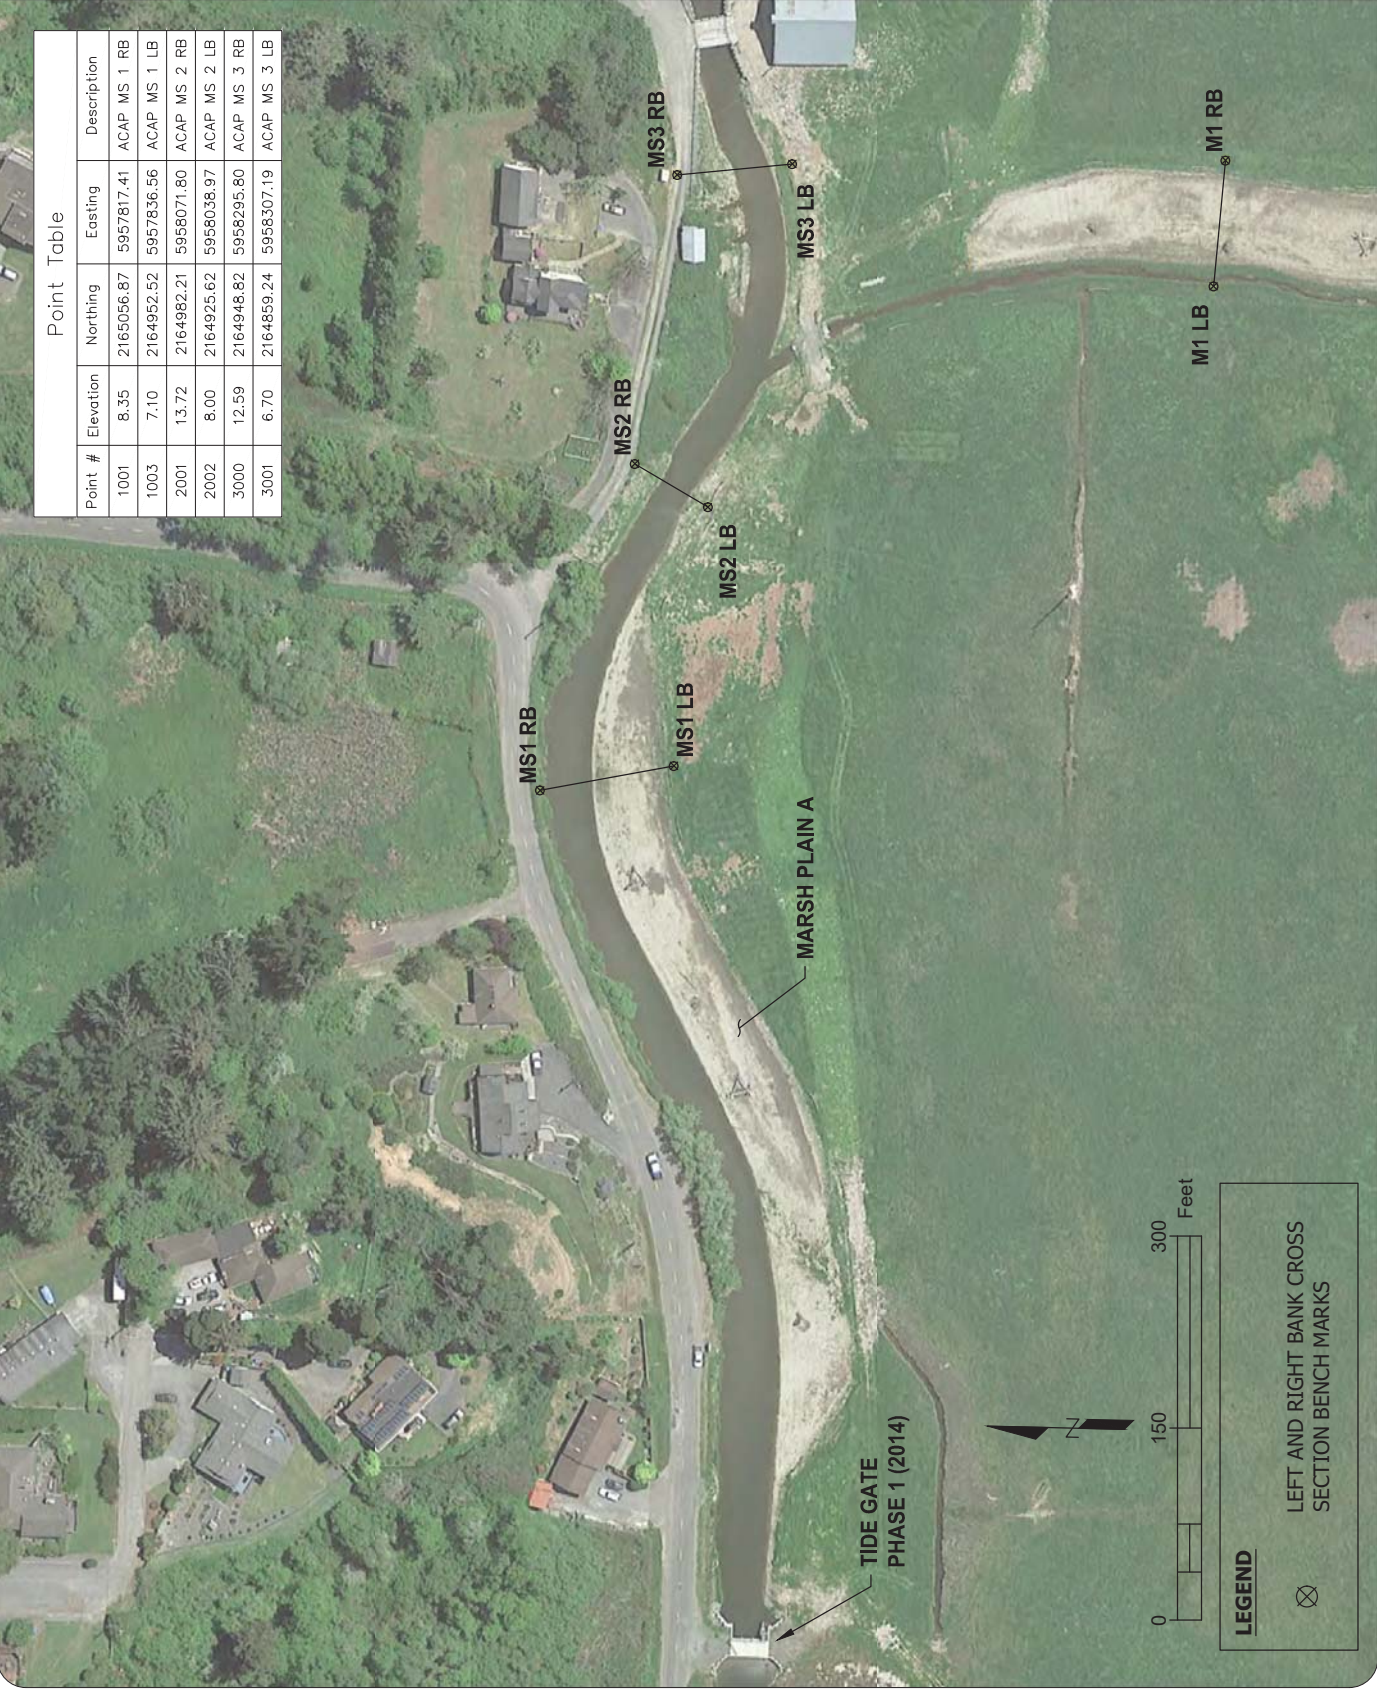
FIGURE
1

MARTIN SLOUGH ENHANCEMENT PROJECT LOCATION OF MONITORING CROSS SECTIONS
